Raindrops keep falling: The Oxford Natural History Museum's leaking roof

The Oxford Natural History Museum has been plagued by water dripping through its roof since its completion but after years of buckets and botched jobs one architect has finally solved the problem. Building finds out how you fix a 154-year-old leak

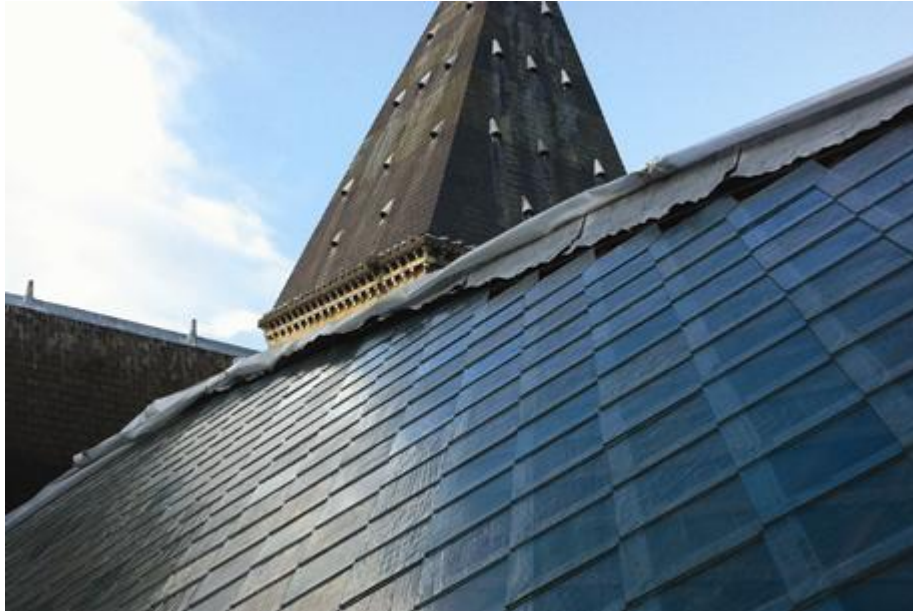
After 150 years the staff of the Oxford Natural History Museum can finally throw away the collection of buckets needed to collect water dripping from the building's leaking roof. The museum has an unusual glass roof that leaked from the day it was completed in 1858 and still leaks today despite various attempts to fix it. The roof is difficult to fix as it is made up of overlapping, square glass tiles similar in construction to a slate roof. These were cast by pouring molten glass into a sand mould resulting in an uneven tile. "Because the glass wasn't flat and varies in thickness the tiles don't sit on each other properly so rain gets blown through the gaps," explains Nicholas Bradley, senior architect with Purcell Miller Tritton, who has been charged with finding a solution. A secondary problem is condensation on the underside of the glass that drips into the museum.

The building has three connected roofs and is covered by 8,566 glass tiles that are 500mm by 500mm and 8mm to 12mm thick. The tiles are screwed to timber battens fixed to timber rafters which in turn are supported by cast iron columns. The tiles are hung in a diamond pattern, two corners of each tile have been cut off so these butt up against neighbouring tiles on the horizontal. When a tile is laid a bead of silicone is applied on the two upper most diagonals of the tile then two tiles are laid on top. Because the silicone bead sits some 65mm away from the edge of the tile above it is protected from the worst of the weather. The gap between the cut-off corners is also filled with silicone. Finally another tile is laid so it sits directly above the first tile, this also overlaps the two horizontal tiles. This results in a small air gap one tile thick that allows air to circulate into the building that should help prevent condensation. It will also allow any condensation that does accumulate to drain out from the underside of the roof. "As long as the roof can breathe the relative humidity should be the same inside as well as out which should take care of the condensation problem," says Bradley.

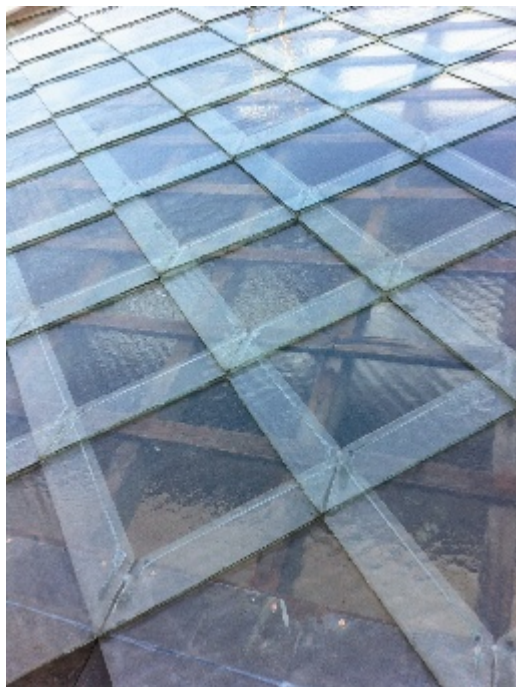
A finished area of roof. The silicone bead that weatherproofs the roof is clearly visible. It is set 65mm back from the edge of the glass tile sitting on top so it is protected from the

weather. A break in the silicone bead at the bottom of each tile allows air to circulate into the building, which helps prevent condensation

Holes are drilled ready for the fixing screws. Beads of silicone are applied with an electrical dispenser. The tile is carefully placed so it overlaps the tiles underneath then screwed down. The safety film isn't being reinstated as this should go on the underside of the tiles. The museum was concerned the film wouldn't stick properly to the rough surface of the tiles and come off, resulting in a maintenance problem.

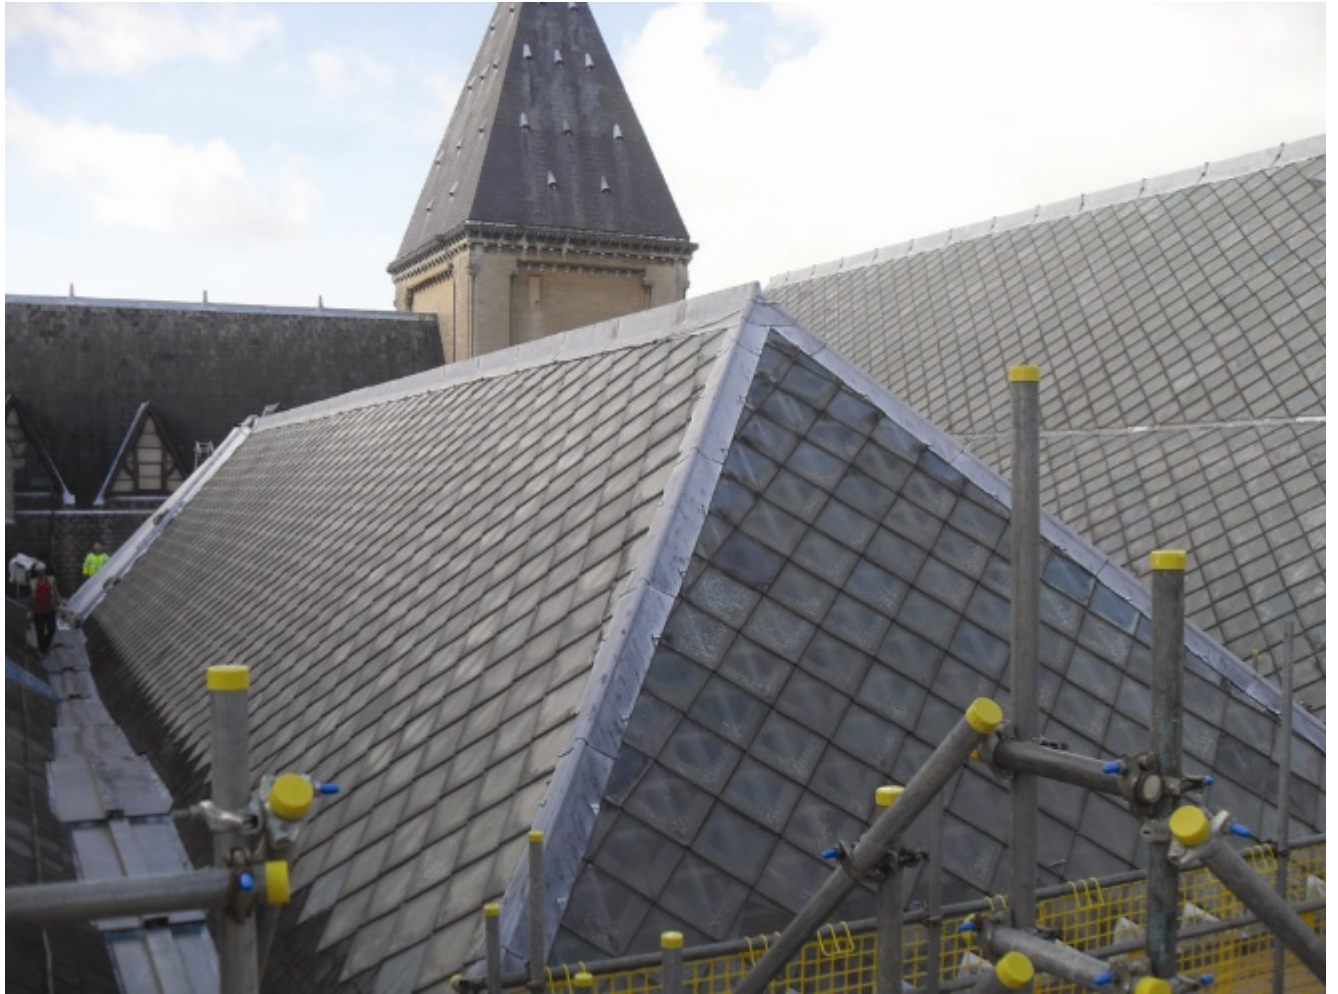
Before restoration the roof leaked and was dirty
